Manhole Inspection Summary

Manhole # S25GG1005MH

Insp Date: **1/23/07 2:17 PM**

Location Address: **1201 40TH ST**

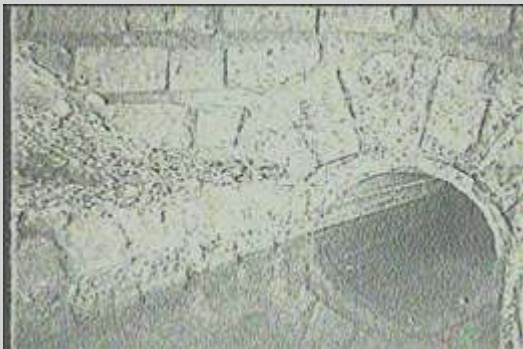
8 in. Circular Gravity Sewer Pipe In @ 7 O'Clock

Invert Depth: **8.45** (ft.) Flow Characteristics: **Slow**

Deposits: ☒ None ☐ Mud ☐ Sludge ☐ Debris ☐ Grease

Infiltration: **None** Pipe Seal Cond: **Unknown**

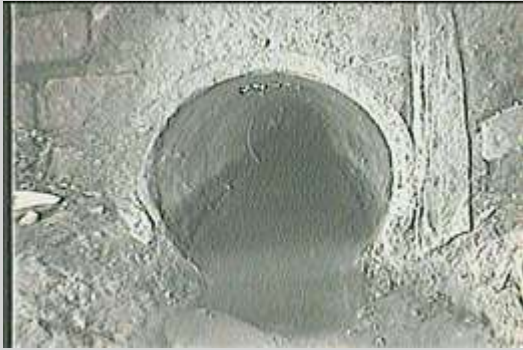
8 in. Circular Gravity Sewer

Infiltration: **None**
